Official Accident Report Index Page

NORTHWEST AIRLINES FLIGHT 18 BOEING 747-251B,
N637US NEW TOKYO INTERNATIONAL AIRPORT NARITA,
JAPAN MARCH 1, 1994

Abstract

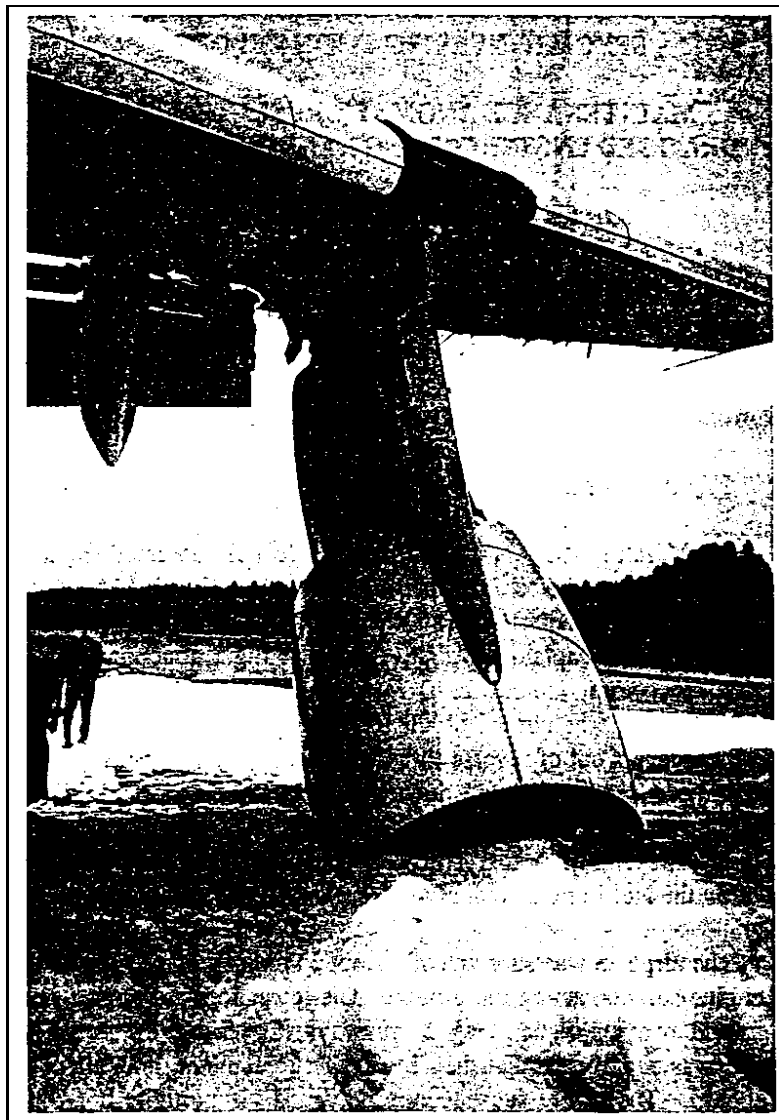
Narita, Japan. According to the captain and first officer, the flight, touchdown, and initial landing rollout at Narita, around 1340 Japanese Standard Time, were routine. Engine thrust reversing was normal on all four engines until the flightcrew moved the engine power levers out of reverse thrust at about 90 knots. During the rollout, the No. 1 engine and pylon rotated downward about the midspar pylon-to-wing fittings into a position in which the lower forward part of the engine nose cowl contacted the runway. The primary forward upper link fuse pin was later found fractured within the No. 1 engine pylon.

The airplane was subsequently stopped on a taxiway, with the front of the No. 1 engine still contacting the ground. The lower forward engine nose cowl had been ground away as it slid along the runway. (See figure 1). A fire near the No. 1 engine was rapidly extinguished by local fire fighters, and all passengers remained aboard. They were subsequently deplaned via portable boarding stairs about 30 minutes after the airplane was brought to a stop. There were no injuries.

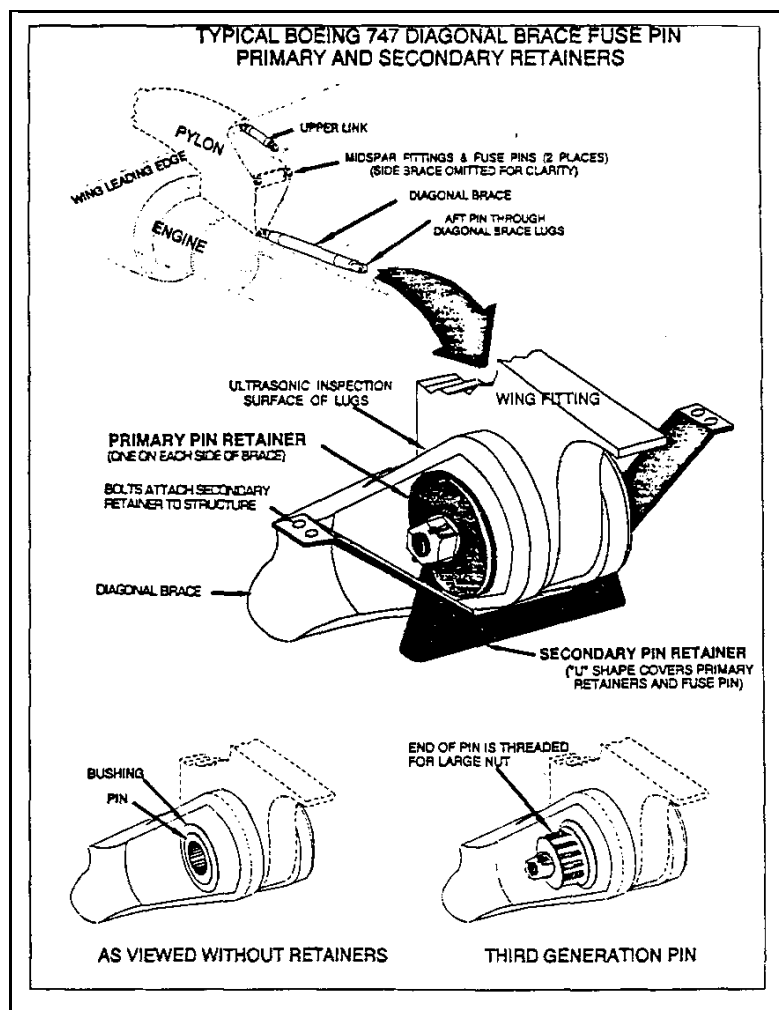
Figure 2.--Diagonal brace attachment details.

The fractured forward upper link fuse pin from the No. 1 pylon was recovered in three pieces and was retained by the JAAIC for metallurgical examination. Examination of the pin revealed that it fractured in static overload and that there was no evidence of preexisting fatigue.

Prior to this landing, at some unknown time, the aft fuse pin on the pylon diagonal brace had migrated out of its fitting. The pin was found loose in the pylon structure. It was intact, undamaged, and had no evidence of preexisting defects. The aft diagonal brace fuse pin is normally retained by both a primary retainer (two washer-like retainer caps and a through bolt) and a secondary retention clip (a bolt-on C-shaped bracket). (See figure 2). However, a search of the airplane pylon and engine area, as well as the runway surface at Narita, revealed neither the aft diagonal brace fuse pin primary nor secondary retaining devices.
